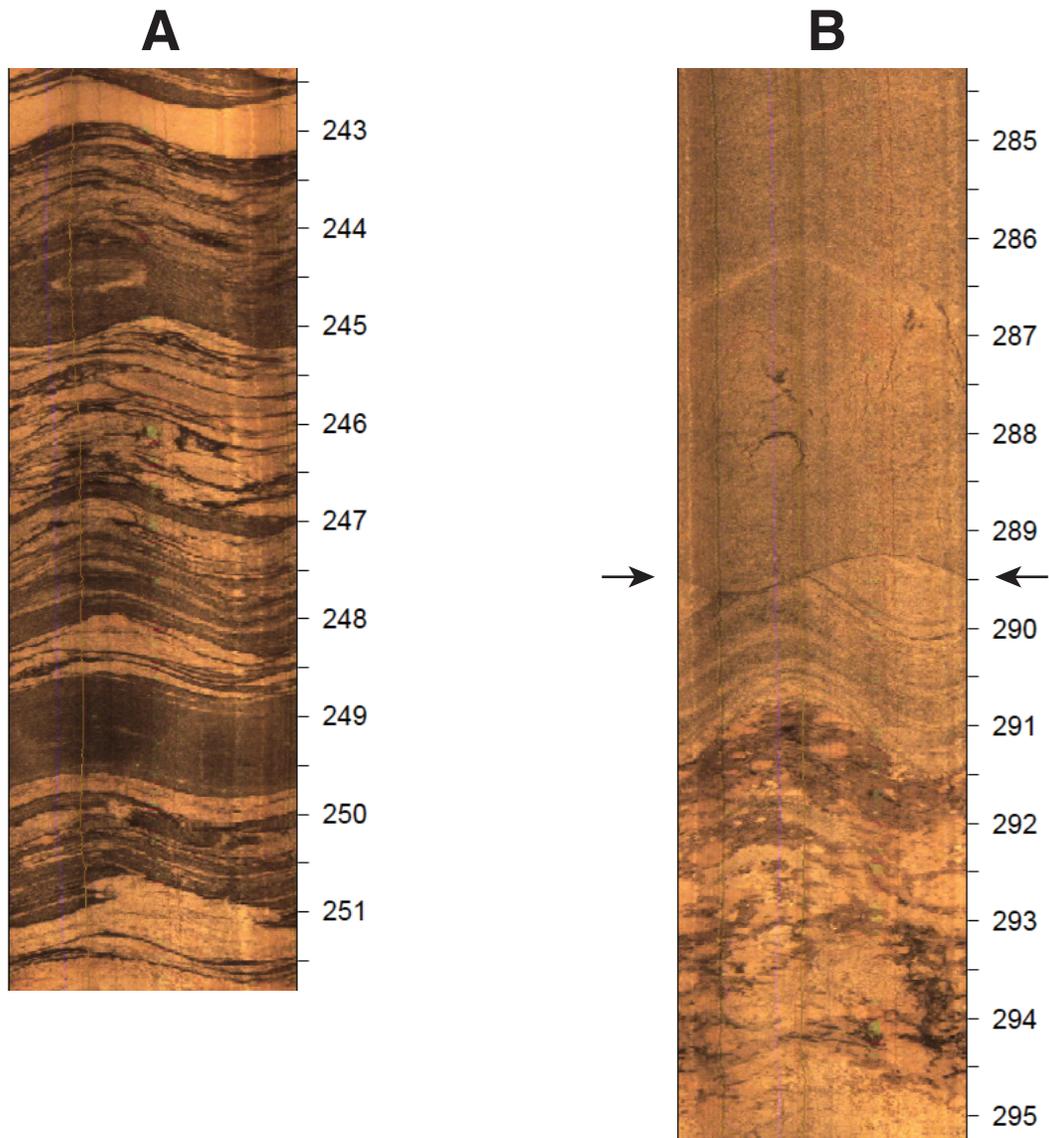
Figure 7. OTV logs of features in bedrock borehole BR-7 (location in Figure 1): A, inclusion of Massabesic gneiss within Milford granite; B, minor fault (arrowed) offsetting foliation. Scale in feet. (From NHDES, 2012).
